Manhole Inspection Summary

Manhole # S53Q__004MH

Insp Date: 11/5/08 1:09 PM

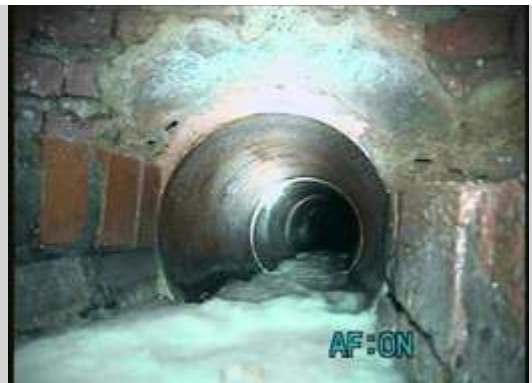
12 O'Clock Outflow

12 in. Circular Gravity Sewer
Pipe Out @ 12 O'Clock

Invert Depth: **16.16** (ft.) Flow Characteristics: **Fast**

Deposits: ☒ None ☐ Mud ☐ Sludge ☐ **Debris** ☐ Grease

Infiltration: **None** Pipe Seal Cond: **Unknown**

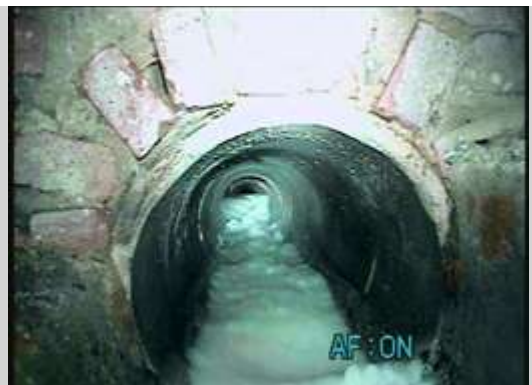
6 O'Clock Inflow

12 in. Circular Gravity Sewer
Pipe In @ 6 O'Clock

Pipe Material: **Clay** ☐ Pipe Lined

Infiltration: **None** Pipe Seal Cond: **Unknown**
